BELZONA PROTECTS WALLS AND FLOORS AT CIDER PLANT

ID: 4707

Customer Location: Cider producer, Herefordshire, UK
Application Date: December 2012

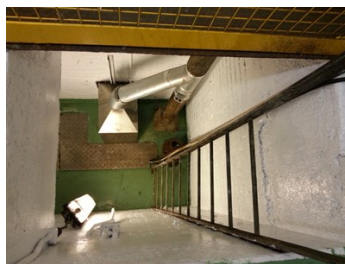
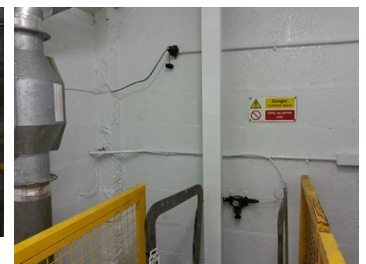
Photograph Descriptions

- * View into pit before application ,
- * pit after application ,
- * walls before application ,
- * walls after application ,

A very damp and dirty pit area.

Application was carried out in accordance with Belzona Know-How System Leaflets WPA-2, FPA-1 and FPA-8. The damaged areas of the floor were rebuilt using the Belzona® 4131 before coating with Belzona® 5231. Belzona® 5111 system was applied to the walls.
