BELZONA SAVES OFFSHORE OIL & GAS PLATFORM FROM SHUTDOWN

ID: 4709

Application: VPF-Valves, Pipes and Fittings

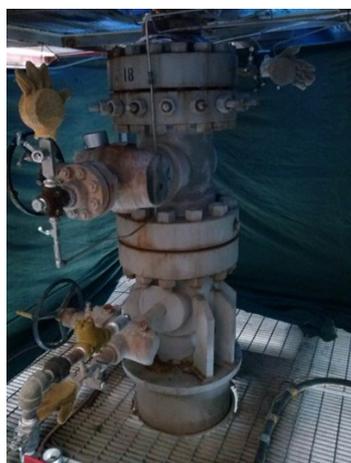
- * Photo of well conductor. ,
- * Photo identifying leak area. ,
- * Abrasive blasting in progress. ,
- * Completed Composite Wrap holding 85 PSI, no leaks. ,

External corrosion to well conductor caused natural gas leak of 85 PSI.
