# BELZONA SAVES OFFSHORE OIL & GAS PLATFORM FROM SHUTDOWN

Customer Location: Gulf of Mexico

Application: VPF-Valves, Pipes and Fittings

Application Date: September 2013

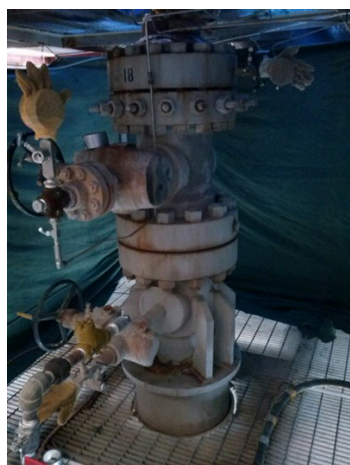
- \* Photo of well conductor. ,
- \* Photo identifying leak area. ,
- \* Abrasive blasting in progress. ,
- \* Completed Composite Wrap holding 85 PSI, no leaks. ,

External corrosion to well conductor caused natural gas leak of 85 PSI.
