BELZONA REPAIRS PST AT WATER TREATMENT PLANT

ID: 4711

Customer Location: Water treatment plant, Gloucestershire, UK

Concrete wall of a Primary Settlement Tank (PST)

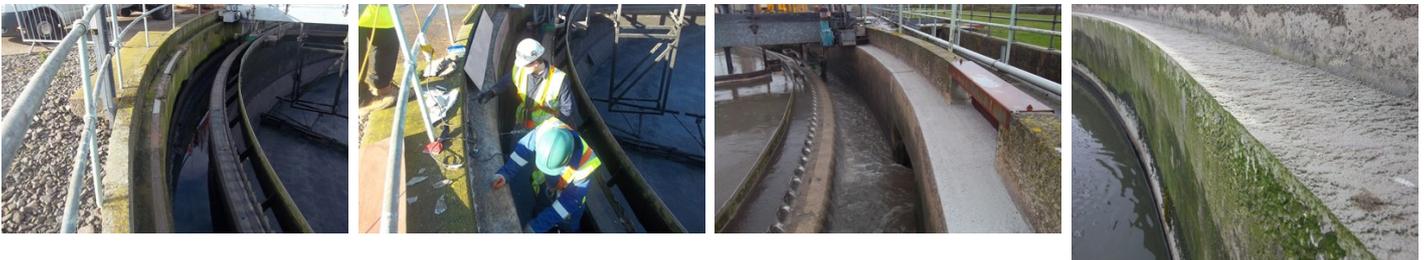
Walls of the running track had become badly worn and damaged over time due to rotation of the distributor. Some areas had been unsuccessfully repaired in the past.

- * Damaged running track and failed previous repairs ,
- * Shuttering boards being installed ,
- * Completed repair back in service ,
- * Repaired areas 12 months on ,

Application was carried out in accordance with Belzona Know-How System Leaflet FPA-1 & FPA-6. Once the surface was prepared, shuttering boards were fitted to the side walls to enable the Belzona® 4131 to be applied to accurate levels. Once the Belzona 4131 had cured the boards were removed and expansion joints cut into the repaired areas. These joints were then sealed with Belzona® 2211.
