BELZONA SOLVES THROUGH WALL CORROSION ON SLUDGE BUFFER TANK

ID: 4712

Customer Location: Sewage treatment site, UK

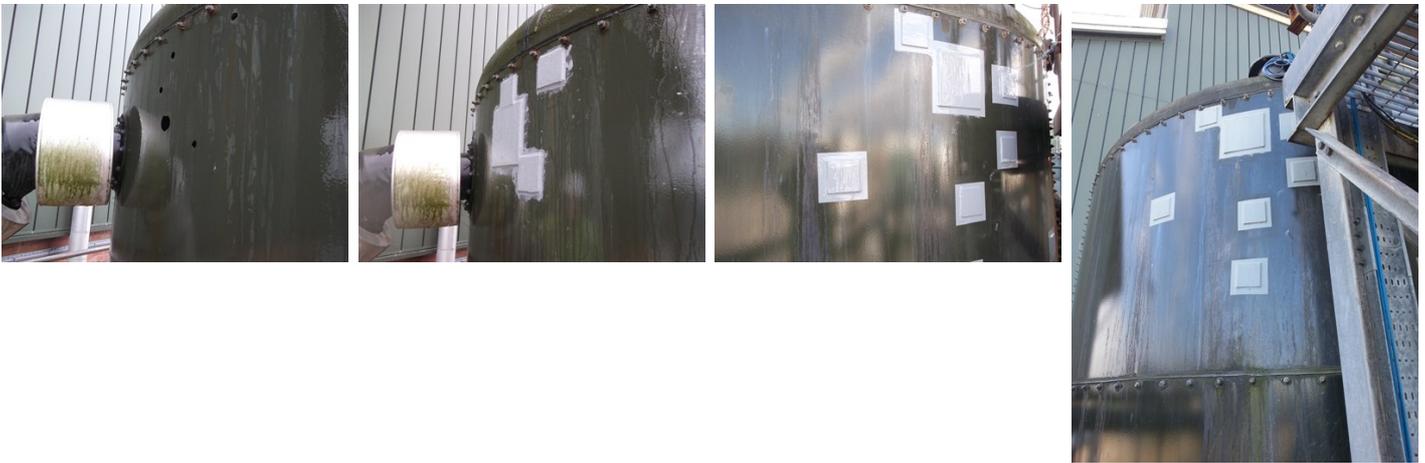
Photograph Descriptions

The sludge buffer tank was suffering from through wall corrosion at the vapour interface level. The tank could not be taken off line for an extended time which traditional repair methods would require due to demand. Any repairs would have to be carried out without hot works or the use mechanical equipment due to the risk of sparks.

* 1, Close up view of through wall defects 2, Plate bonding with Belzona 1161 3, Repairs coated with Belzona 5831 4, Inspection in 2015 ,

The application was carried out in accordance with Belzona Know-How System Leaflet TCC-3. After cleaning the areas, surface preparation by hand abrasion was carried out. Repair plates pre-coated with Belzona 5831 were cold plate bonded over the through wall defects using Belzona 1161. Finally Belzona 5831 was applied to the entire repair areas.

The job was inspected in 2015 and found to be in perfect condition.
