BELZONA EXTENDS LIFE OF CYCLONE CONES IN QUARRY WASH PLANT

Industry: Mining & Quarrying
Application: SHM-Solids Handling Machinery

Customer Location: Lime stone quarry, SW, England
Application Date: February 2012

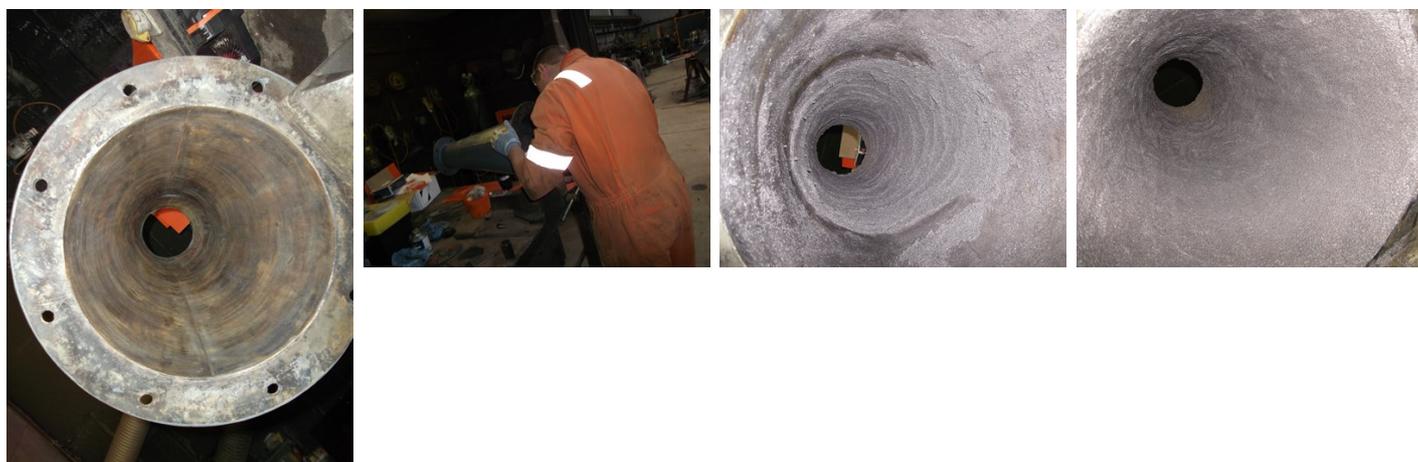
Photograph Descriptions

The cones suffer heavy levels of abrasion. The mean times between failures of the cones was not acceptable even after the rubber coating was applied and continuing stoppages of the plant had large cost implications. Belzona was selected for a trial application to increase the working life of these components.

- * Cone prior to application ,
- * Clients staff carrying out application ,
- * Belzona® 1812 during application ,
- * Completed application of Belzona® 1812 to cone ,

Cones on cyclone wash plant filtration. Non-protected cones were failing within one month and rubber coated cones only lasted for six months.

The application was carried out in accordance with Belzona Know-How System Leaflet SHM-13.

Original cones with no coating last 1 month. ☒☒ Rubber lined cone lasts 6 months cost per cone £150 Belzona solution lasted 18 months. Cost per cone £200 The largest cost saving was on down time to the wash plant. After the successful trial the client has now made the Belzona solution the standard for all the abrasion areas within this plant.
