# BELZONA SEALS LARGE BUND AREA

ID: 4714

**Industry:** Steel & Metal Processing  
**Application:** TCC-Tanks and Chemical Containment Areas

**Customer Location:** Metals manufacturer, Herefordshire, UK  
**Application Date:** November 2012

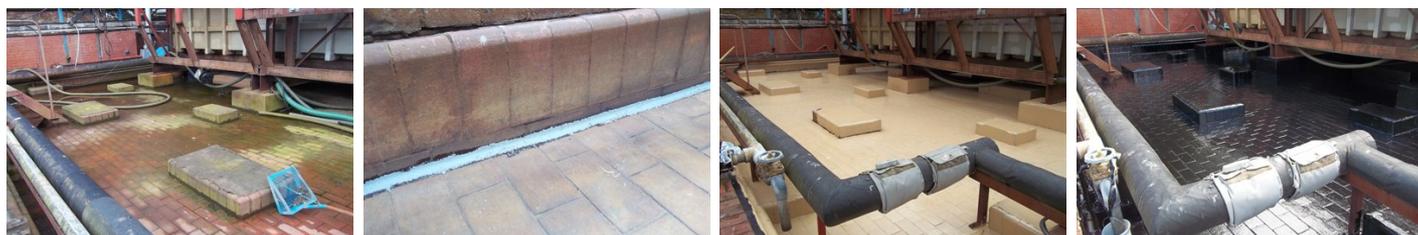
## Photograph Descriptions

The site is very keen on keeping up there high standards in health and safety and environmental issues and so regularly test for leaks .The bund was leaking in many areas through the brickwork.

- \* Before application ,
- \* Creation of fillets at wall/floor joint with Belzona 4131 ,
- \* Application of first coat Belzona 5811 ,
- \* Completed application ,

Application was carried out in accordance with Belzona Know-How System Leaflets TCC-9 and TCC-15. The application took place during the planned two week shutdown and so no disruption to production.
