# BELZONA SEALS LARGE BUND AREA

ID: 4714

Application: *TCC-Tanks and Chemical Containment Areas*

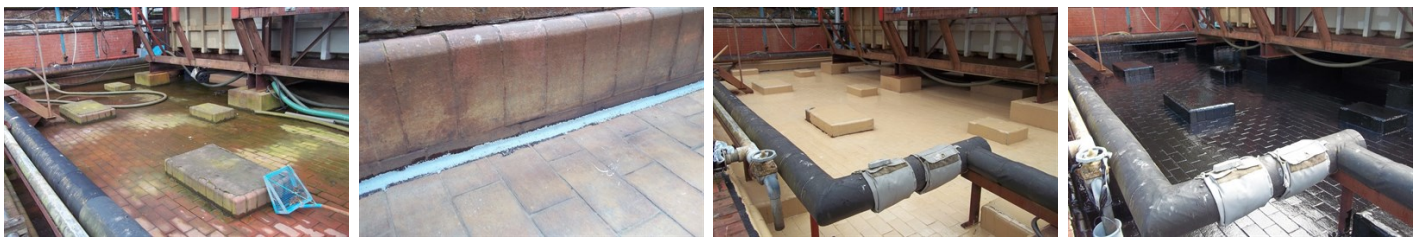
*The site is very keen on keeping up there high standards in health and safety and environmental issues and so regularly test for leaks .The bund was leaking in many areas through the brickwork.*

- \* Before application ,
- \* Creation of fillets at wall/floor joint with Belzona 4131 ,
- \* Application of first coat Belzona 5811 ,
- \* Completed application ,

Application was carried out in accordance with Belzona Know-How System Leaflets TCC-9 and TCC-15. The application took place during the planned two week shutdown and so no disruption to production.
