# BELZONA SOLVES FINLOCK GUTTER ISSUES

ID: 4715

Customer Location: *Housing Association, Herefordshire, UK*  
Application Date: *March 2013*

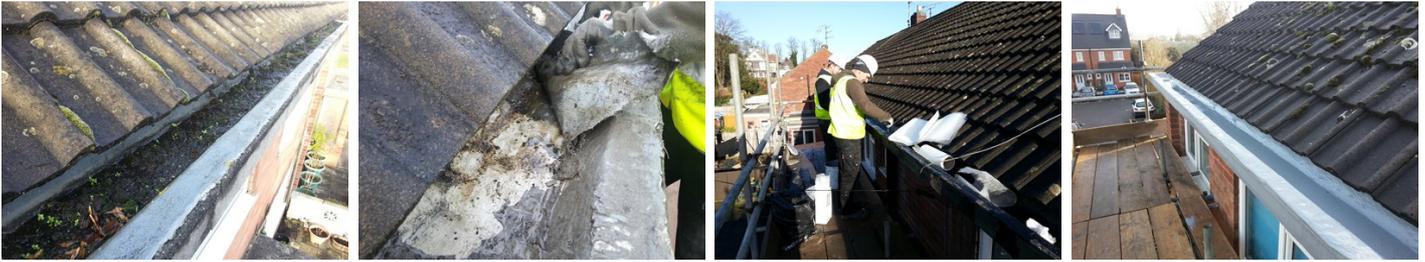
*Finlock gutters had begun to leak into the properties.*

\* 1. Before Application 2. Removal of existing liners 3. Application in progress 4. Completed Application. ,

Application was carried out in accordance with Belzona Know-How System Leaflets RPA-6 and RPA-11. Any damaged areas of concrete were repaired using Belzona 4141 followed by complete coating with the reinforced Belzona 3131 system.
