BELZONA HELPS KEEP THE PORT OPEN.

ID: 4716

Industry: *Marine*
Application: *SOS-Ships and Offshore Structures*

Customer Location: *Port authority, London, UK*
Application Date: *August 2013*

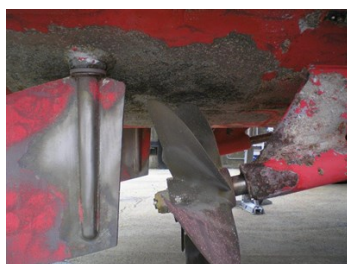
* 1, The vessel 2, The affected areas 3, Cleaned, blasted and Belzona 1111 applied 4, Belzona 1341 applied ,

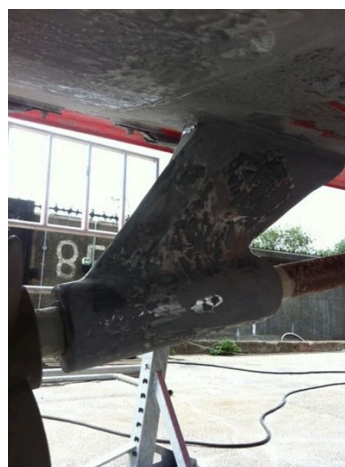
After 10 years of service on the river the hull of the vessel was suffering from cavitation around the propellor area. Previous repair method had been welding.
