BELZONA EXTENDS VALVE BODY LIFE

Industry: Power
Application: VPF-Valves, Pipes and Fittings
Substrate: Cast Iron
Products: * Belzona® 1111 (Supermetal) ,
* Belzona® 2141 (ACR-Fluid Elastomer) ,

Customer Location: Power station, Kent, UK.
Application Date: September 2013

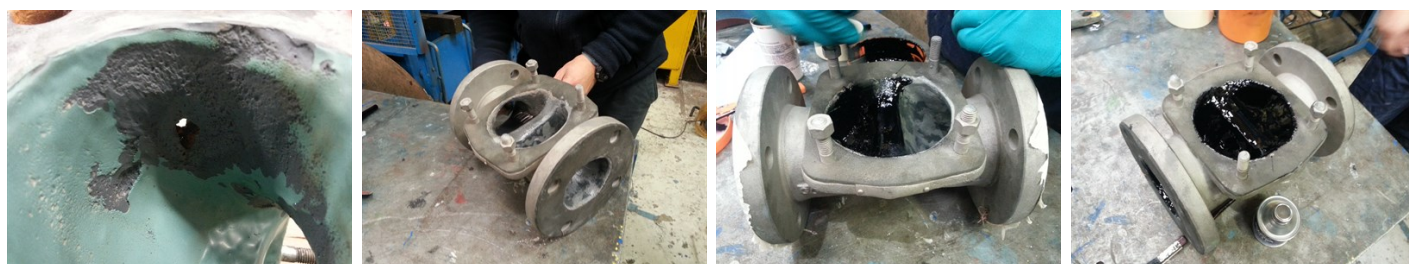
Photograph Descriptions

The valve body was suffering from cavitation and would only last 4-6 weeks before breaking through the casting.

- * Through wall erosion damage ,
- * Blasted and Belzona® 1111 applied ,
- * Belzona® 2141 being applied ,
- * Finished application ,

The valves are supplied on a regular basis and previous coating would erode very quickly and the valve body would need replacing every 4-6 weeks. Using Belzona® 2141 system the effects of the cavitation have significantly been lowered resulting in less downtime & cost savings.
