# BELZONA RESTORES GRADE 2 LISTED BUILDING

Sandstone window frames and roof edges on a cemetery lodge building (built circa 1912).

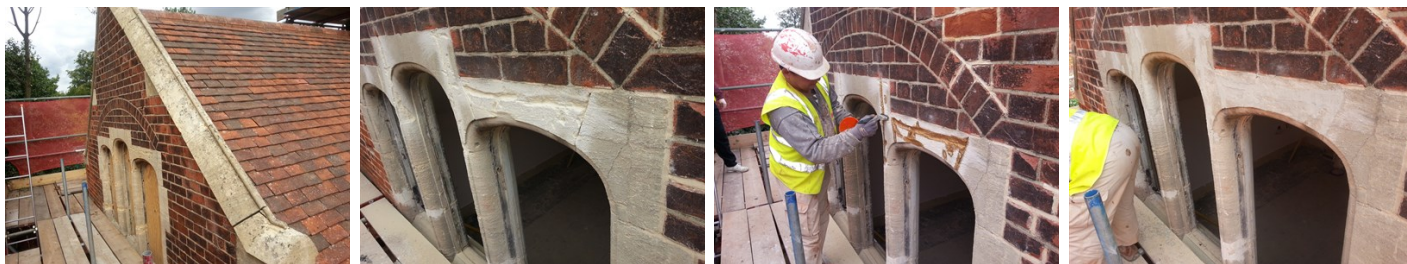
*The sandstone window frames and roof edges were corroded and cracked due to many years of weather damage*

- \* Sandstone window frames before being repaired ,
- \* Areas of broken stone removed ,
- \* Belzona® 4911 TX conditioner being applied to prepared areas ,
- \* Areas rebuilt with Belzona® 4141 (stone colour) ,

Application was carried in accordance with Belzona Know-How System Leaflets WPA-4 and WPA-6. After removing the areas of weathered and broken sandstone, Belzona® 4141 Magma Build was then used to rebuild the sandstone back to the original profile.
