# BELZONA GETS HOT AND HUMID

ID: 4722

Industry: Food & Drink  
Application: VPF-Valves, Pipes and Fittings  
Substrate: Carbon Steel  
Products: \* Belzona 5831 (ST Barrier) ,

Customer Location: Food Production Plant, UK  
Application Date: 2011

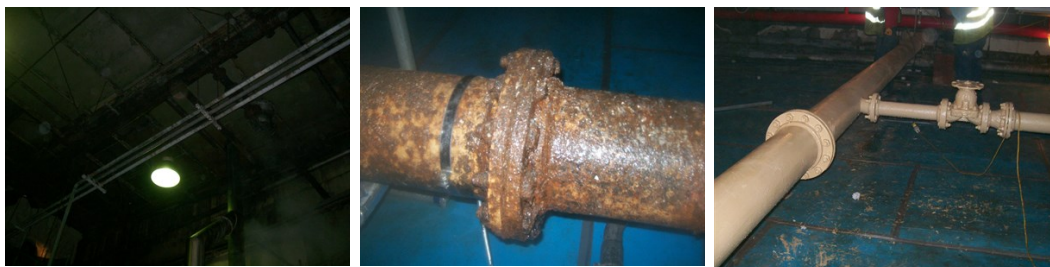
A well known crisp manufacturer had a series of aging gas pipes of diameters ranging between 4 to 8 inch. These heavily corroded pipes were located in the ceilings above production equipment and the packing conveyors. In addition, because of the processes in the rooms beneath, the roof area had excessive heat and humidity, with water condensate perpetually laying on the pipes. Grit blasting was not an option due to production beneath and so Belzona was approached to offer an anti-corrosion system that could be applied in such difficult circumstances.

\* 1. Location of gas pipes in ceiling 2. Corroded pipe with constant surface condensate 3. Finished section of pipe from Phase 1. ,

Application was carried out in accordance with a modified version of Belzona System Leaflet VPF-2. the pipes were hand wire brushed to ST2 standard and then 2 coats of Belzona 5831 applied by brush

The restrictions to preparation, coupled with the high air temperatures and excessive humidity were overcome by the surface tolerant properties of the Belzona 5831 and the client was delighted that there was no loss of production in the areas below, and no potential for contamination of their products.
