BELZONA USED IN WINDMILL REFURBISHMENT

ID: 4728

Customer Location: Windmill, Buckinghamshire, UK
Application Date: April 2013

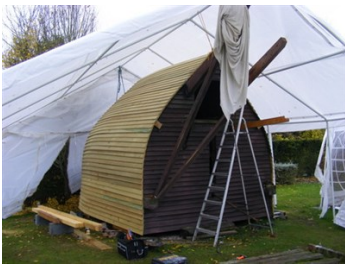
- * The cap on the ground with freshly replaced timbers ,
- * First layer of Belzona 3111 being applied ,
- * & 4. Finished application with cap fitted back in place ,

Once the sails had been removed the wooden cap was taken down and work could commence to replace any rotten or damaged timber. Upon completion of the structural work the fully reinforced Belzona 3111 system was applied in accordance with Belzona System Leaflet RPA-1. With all the overlapping timbers it required the patience of a craftsman to carefully lay the reinforcing sheet into the Belzona 3111 to achieve a wrinkle free finish with the sheet closely following the substrate profile.
