BELZONA MAKES RAMP SAFE

ID: 4729

Application: FPA-Floor Problem Areas

Customer Location: Local Authority, Derbyshire, UK

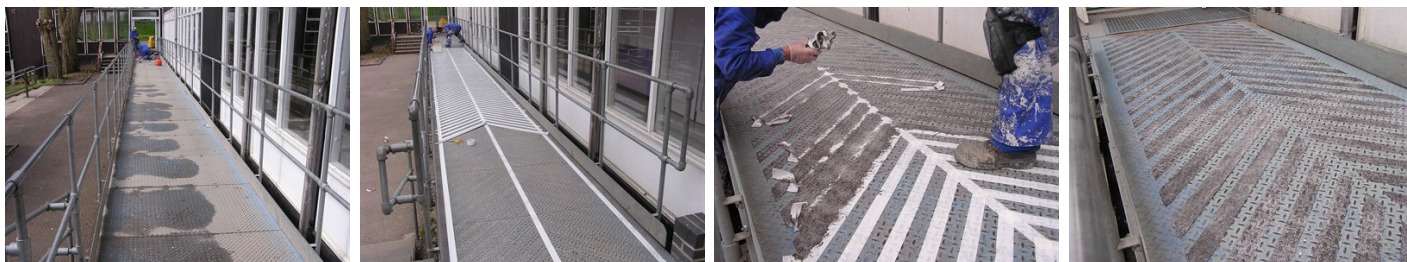
Photograph Descriptions

The chequerplate had become polished and slippery especially when wet.

- * Long chequerplate walkway before application ,
- * Chequerplate showing preparation and correct masking to provide chevron pattern ,
- * Application by brush with immediate removal of masking tape ,
- * Finished job ,

Application was carried out in accordance with Belzona Know-How System Leaflet FPA-8. After preparing the substrate and masking the chevron pattern on the surface the Belzona® 1821 was applied and aggregate tamped into the surface before removing the masking and allowing system to cure overnight.

Even though chequerplate is known to have a pattern across its surface this had become polished and had become very slippery especially when wet. The Belzona® 1821 grip system applied along the surface of the chequerplate provided added positive grip and safety for pedestrians.
