BELZONA REBUILDS WORN STONE STAIRCASES BUILT IN 16TH CENTURY

Customer Location: College in Cambridge, UK
Application Date: August 2012

Badly worn stone steps on staircases built in the 16th Century

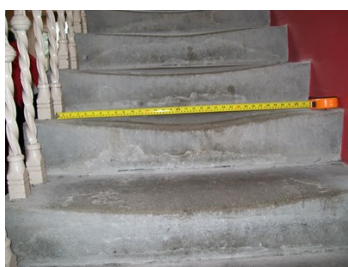
The stone steps on several staircases in this Grade 2 listed College had become badly worn over the last 500+ years of use and so were considered a Health and Safety risk. The steps had worn by up to 75mm deep in the centre, sloping towards the front so were slippery when wet. Due to the design of the stone steps it was not possible to cut out the worn area and repair in the traditional manner of inserting a new block of stone because this would weaken the staircase.

- * Worn stone steps before, with wear up to 75mm deep in centre of step ,
- * Wooden formers in place and Belzona 4911 being applied ,
- * Belzona 4131 being installed with wooden former helping keep the repair flat and level ,
- * Example of step rebuild completed with Belzona 4131 ,
