# STORM TANK AT SEWAGE WORKS REPAIRED WITH BELZONA PLATE BONDING

Customer Location: Water treatment plant, East Sussex, UK

Application: TCC-Tanks and Chemical Containment Areas

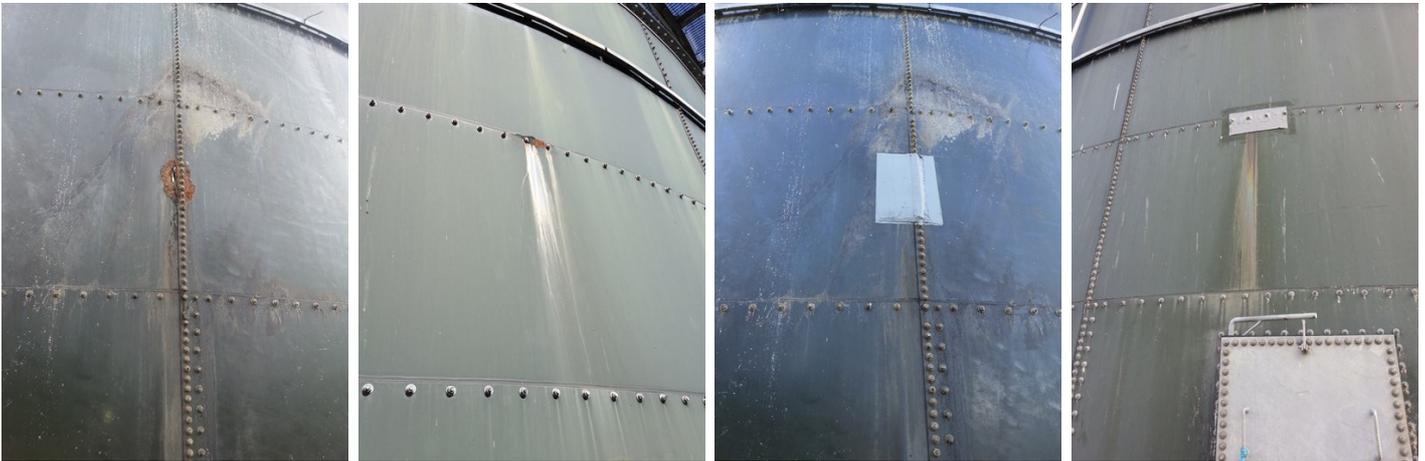
The tank was suffering from corrosion issues around the seam areas. In two places the corrosion was through wall and raw sewage was leaking out of the sides. Whilst a decision was being made as to whether or not to build a new tank or repair the existing was made we were asked to apply some temporary patches so the tank could still be used.

\* 1. Through wall corrosion area requiring cold plate bonding 2. Corroding seam 3. Completed plate bond 4. Patch repair to seam complete ,

Application was carried out in accordance with Belzona System Leaflet TCC-1 & TCC-3. After cleaning and preparing surface with an MBX Bristle Blaster, Belzona 1211 impregnated into Belzona 9341 (Reinforcement Tape) was used to cover area before conducting a cold plate bond using Belzona 1161.

All works had to be carried out in one day as the tank had to be put back into service at the end of the shift. By using the Belzona 1211 to patch over any holes reduced the chance of failure when the tank was filled shortly after the repair. The use of Belzona 1161 with its surface tolerant properties allowed the repair to be submerged whilst curing. The customer was very happy with the repairs and instead of building a new tank is going to line the inside with a Belzona System.
