BELZONA REPAIRS SPALLED LINTELS ON SCHOOL

Application: WPA-Wall Problem Areas

Customer Location: Primary School, Blackpool, UK

Application Date: February 2012

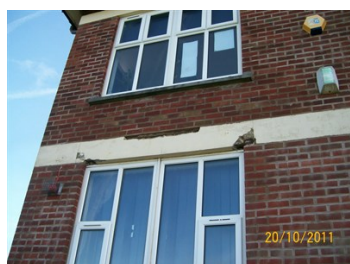
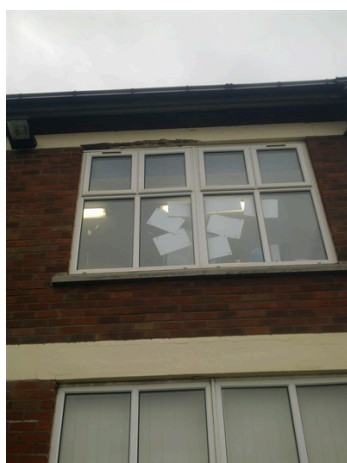
Pieces of concrete breaking away from the lintels were deemed a safety hazard and needed urgent solution to be completed during half term school holiday.

* 1 & 2. Some of the damaged lintels and sills before application 3 & 4. Completed repairs ,

School exposed to local marine environment. A number of concrete lintels and sills, particularly those over-looking the playground and exposed to the prevailing winds and sea spray were in need of urgent refurbishment.

Application was carried out in accordance with Belzona System Leaflet WPA-4. Areas were hammer tested to detect early signs of spalling and all loose concrete hacked off to leave solid substrate. Exposed rebar was abraded back to bright metal before building back to original profile with the Belzona 4141 system.
