BELZONA REPAIRS SPALLED LINTELS ON SCHOOL

Customer Location: Primary School, Blackpool, UK

Application: WPA-Wall Problem Areas

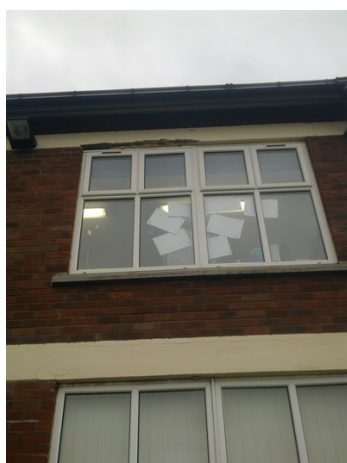
Pieces of concrete breaking away from the lintels were deemed a safety hazard and needed urgent solution to be completed during half term school holiday.

* 1 & 2. Some of the damaged lintels and sills before application 3 & 4. Completed repairs ,

School exposed to local marine environment. A number of concrete lintels and sills, particularly those over-looking the playground and exposed to the prevailing winds and sea spray were in need of urgent refurbishment.

Application was carried out in accordance with Belzona System Leaflet WPA-4. Areas were hammer tested to detect early signs of spalling and all loose concrete hacked off to leave solid substrate. Exposed rebar was abraded back to bright metal before building back to original profile with the Belzona 4141 system.
