BELZONA UPGRADES SCHOOL POTWASH FLOOR

ID: 4737

Industry: Buildings & Structures
Application: FPA-Floor Problem Areas
Substrate: Concrete
Products: * Belzona 5811 (Immersion Grade) ,

Customer Location: College, Sussex, UK
Application Date: 2012

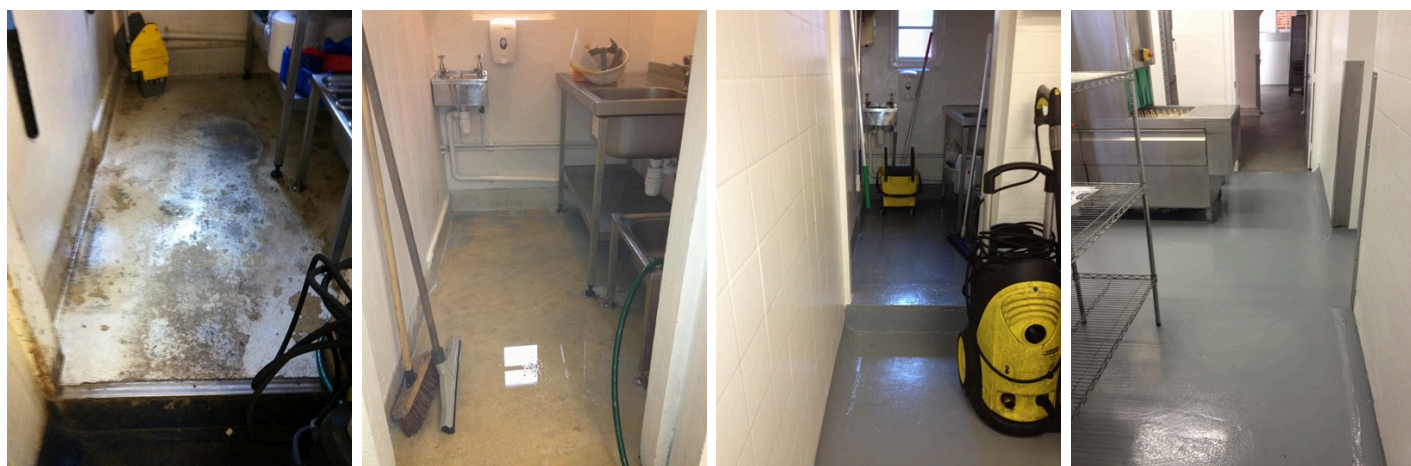
Photograph Descriptions

The College required a protective coating for the washroom area in the kitchen. The coating should be able to withstand constant immersion in water and should incorporate slip resistance

* 1. The pot wash floor before work commenced 2. After being cleaned and grit blasted 3. The pot wash floor after application 4. The loading/sorting area also coated ,

The existing floor coating had only been down 6 months and was failing, trapping dirt and grease and generally not very hygienic. The Belzona solution was selected as it has proven track record, could easily withstand the activity of washing 1000's of dishes a day and that when applied it doesn't give off an odour. Adding aggregate allowed a non slip surface to be created ensuring safety of the staff on what would otherwise be a very slippery floor

Application carried out in accordance with Belzona System Leaflet FPA-3 and FPA-8. The Belzona 9231 (Surefoot Aggregate) was broadcast on the surface of the Belzona 5811 to create a non-slip surface.
