BELZONA IMPOUNDMENT PUMP COATING SIX YEARS ON

ID: 4748

Customer Location: Port Authority, SW England
 Application Date: Sept 2013

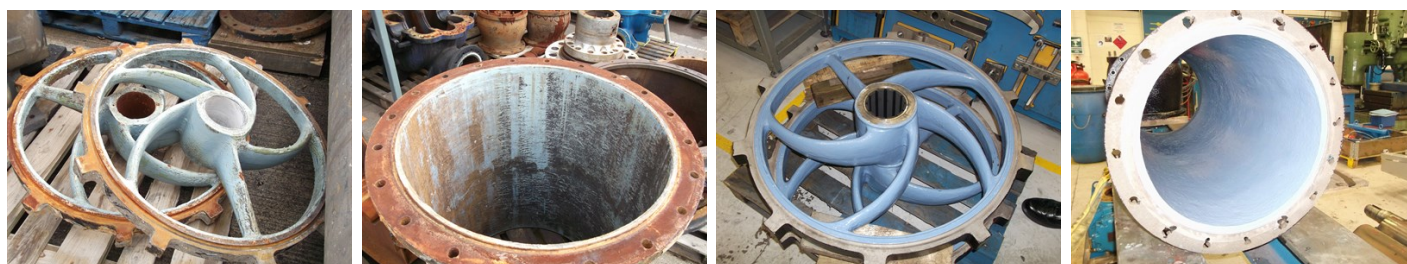
Photograph Descriptions

* 1. Spider bearings after 6 years in service 2, Pump casing very little wear to the Belzona 1341 3. Spider bearings re-coated with Belzona 1341 4. Pump internals after coating ,

Application was carried out in accordance with Belzona Systems Leaflet CEP-10. The existing Belzona 1341 showed very little wear and small amount of build-up was cleaned by pressure washing before completing the surface preparation and re-coating with Belzona 1341.

Due to the harsh environment in which the pumps operate, the Client has made the coating of all the pumps with Belzona 1341 standard due to both the increase in efficiency and the extension of pump life provided.
