# BELZONA REPAIRS OIL COOLERS

**Industry:** Steel & Metal Processing  
**Application:** HEX-Heat Exchangers  
**Substrate:** Brass, copper and gray iron.  
**Products:** \* Belzona 1311 (Ceramic R Metal) ,  
\* Belzona 1391 (Ceramic HT) ,

**Customer Location:** Ferronickel plant, Macedonia  
**Application Date:** August 2012

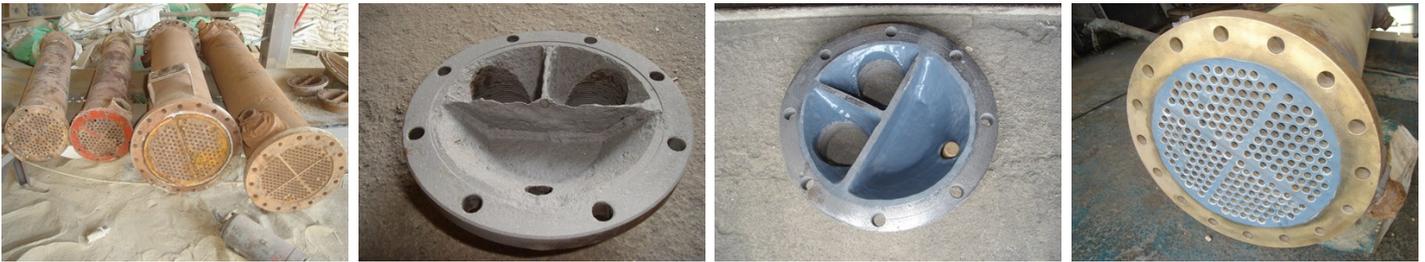
Heat exchangers were suffering from electrochemical corrosion. Gaps occurred between tube sheet and tubes and cooling water and oil started to mix.

- \* Heat exchanger ready for grit blasting ,
- \* The condition of end cover after blasting ,
- \* End cover repaired with Belzona 1311 and protected with Belzona 1391 ,
- \* Tube sheet repaired and protected ,

Application was carried out in accordance with Belzona Know-How System leaflets HEX-1 and HEX-3.

The customer first tried to weld the tubesheets, but was not successful. After completing repairs with Belzona the customer was very satisfied and this year a further cooler has been repaired.
