BELZONA REPAIRS DAMAGED PORCELAIN SHED

ID: 4750

Customer Location: Power Distribution Company Substation, UK

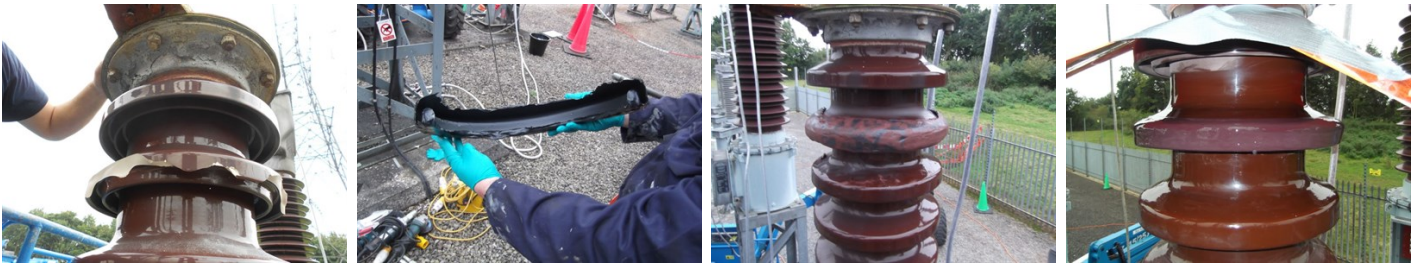
Photograph Descriptions

- * Damaged porcelain shed ,
- * Elastomer former mould ,
- * Elastomer former with Belzona 8112 attached to shed ,
- * Completed repair with innovative rainfall protection ,

Porcelain shed damaged by contact with mechanical platform access lift during outage procedure.

The porcelain insulator rebuild repair was completed in accordance with the Belzona Know How System VPF-16
