BELZONA REBUILDS AND PROTECTS SEAWATER STRAINER

ID: 4783

Customer Location: Dry Dock Facility, Newfoundland,
Canada

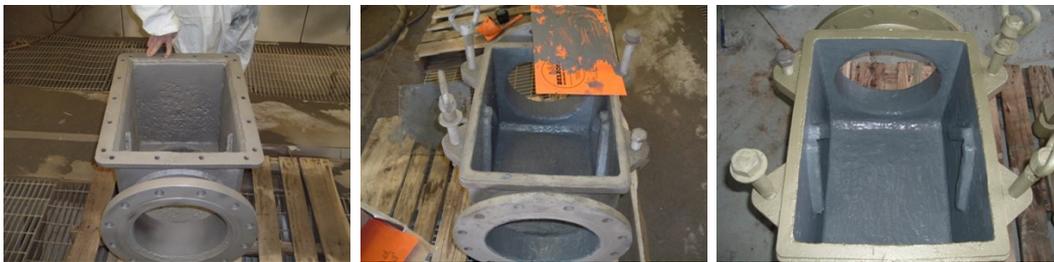
Photograph Descriptions

Erosion corrosion was taking its toll on the inner surfaces of this seawater strainer. Years of inadequate protection from inferior coatings was dramatically reducing the span of this important piece of equipment.

- * The extent of the corrosion damage can be seen after the seawater strainer has been grit blasted ,
- * The pitted areas were rebuilt with Belzona 1311 ,
- * The completed repair after the application of 2 coats of Belzona 1321 ,

Application was carried out in accordance with the modified Belzona System Leaflets SOS-1 & -2.

Conventional coatings cannot handle the erosion and corrosion and microbiological attack this equipment is subjected to. Conventional repair methods such as welding are not possible.
