# BELZONA REPAIRS CONCRETE HULL

ID: 4785

Industry: Marine  
Application: FPA-Floor Problem Areas  
Substrate: Reinforced Concrete  
Products: \* Belzona 4111 (Magma Quartz) ,

Customer Location: Engineering Company, BC, Canada  
Application Date: October 2009

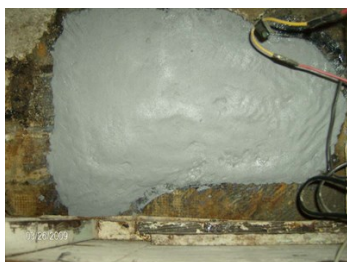
The bottom of the hull had been attacked by leaking battery acid. Also while docked another vessel had collided with the yacht damaging its hull.

- \* The concrete hull had been damaged by leaking battery acid ,
- \* After neutralizing and preparing the area with a grinder rebuilding with Belzona 4111 began ,
- \* During the repairs hull was damaged ,
- \* Hull repaired with Belzona 4111 and then sanded down to smooth finish before repainting. ,
