# BELZONA® PREVENTS LEAKS INTO ELECTRICAL ROOM

Industry: *Buildings & Structures*  
Application: *RPA-Roof Problem Areas*  
Substrate: *Brick and Concrete*  
Products: *\* Belzona 3121 (MR7 Membrane) ,*

Customer Location: *Hotel Chain, Vancouver, BC, Canada*  
Application Date: *October 2009*

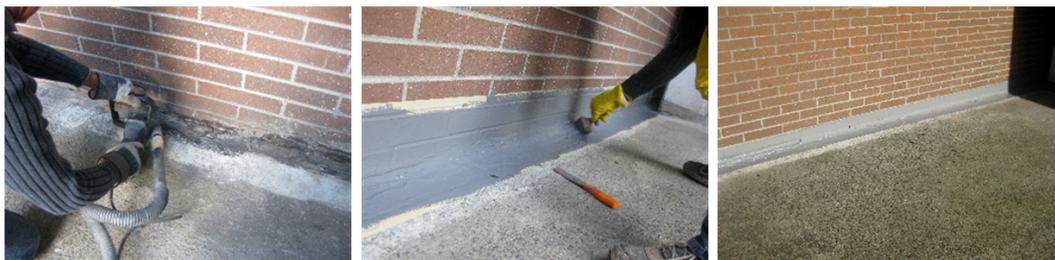
\* 1. Surface preparation underway 2. The area was masked off before the 1st coat of Belzona 3121 was applied 3. A 2nd coat of Belzona 3121 was applied along with reinforcing sheet to ensure that the gap was adequately bridged. A 3rd coat was applied to complete the application. ,

A leak had developed between the brick wall and the parking garage floor.

Application was carried out using a modified version of Belzona System Leaflet RPA-1. The area along the wall and concrete floor was ground with a Vac-grinder to ensure a good surface for bonding before applying the Belzona 3121 system.
