BELZONA ADDS SAFETY TO SWIMMING POOL STAIRS

ID: 4788

Customer Location: Swimming Pool, Nova Scotia, Canada
Application Date: September 2009

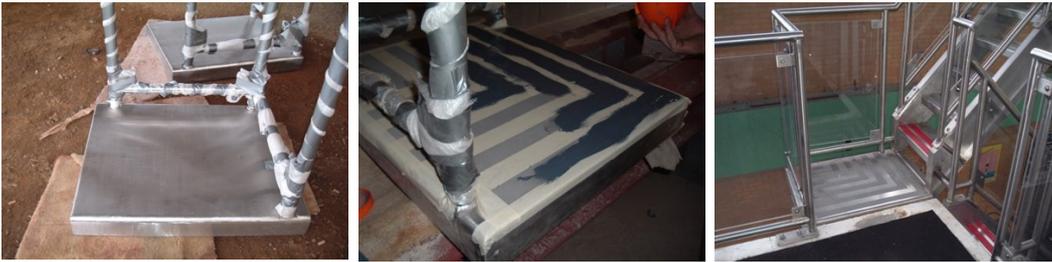
Because of the corrosive environment stainless steel was used for the construction and unfortunately the base was very slippery.

- * The surfaces of the stainless steel landings were grit blasted to ensure good adhesion to the metal surface ,
- * The area was masked off in a chevron style pattern to ensure adequate safety for the multi directional traffic the landing would be subjected to ,
- * The completed application installed at the base of the diving tower. ,

The swimming pool facility was upgrading the access stairs to the diving tower.

Application was carried out in accordance with a modified version of Belzona Know-How System Leaflet FPA-8.
