BELZONA PROTECTS BRINE SEPARATOR

ID: 4794

Industry: Oil & Gas
Application: TCC-Tanks and Chemical Containment Areas
Substrate: Mild Steel
Products: * Belzona 1511 (Super HT-Metal) ,
* Belzona 1521 (HTS1) ,

Customer Location: Oil Company, Canada
Application Date: 2009

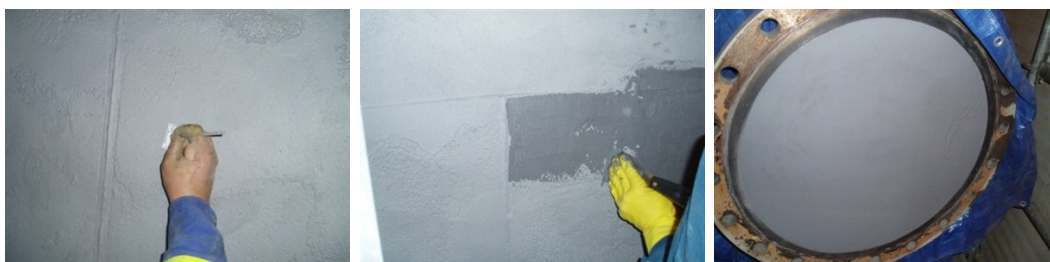
Corrosion pitting and erosion was taking its toll.

- * Surface after blasting to 3-4mil profile ,
- * Pitted areas were brush blasted prior to over coating ,
- * Completed application ,

The vessel had previously been patch repaired with Belzona 1591 HT Ceramic during shutdowns and was now slated for a complete refurbishment.

The application was carried out in accordance with Belzona Know-How System Leaflet TCC-01. The surface of the vessel was blasted to a 3-4mil profile using aluminum oxide blasting grit. The pitted areas of the vessel were rebuilt with Belzona 1511, a high temperature rebuilding compound specifically formulated for these types of applications. The rebuilt areas were brush blasted prior to over coating. After strip coating all internal weld areas and outer edges, complete vessel and man cover were protected with Belzona 1521.

Protecting the inside of the tank with Belzona 1521 will extend the vessels' useable life.
