BELZONA PROTECTS HIGH TEMPERATURE ISOLATION SPOOL

ID: 4799

Customer Location: Off-shore Production Company, Canada
Application Date: November 2009

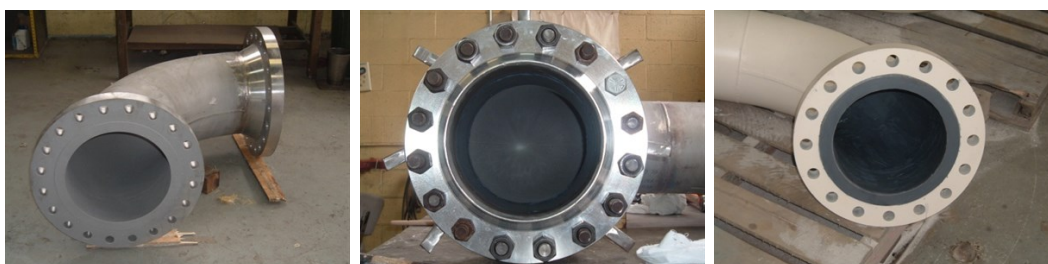
Photograph Descriptions

The original rubber lining and conventional coatings were unable to handle these adverse conditions and failed within a very short space of time.

- * Section of piping after surface preparation had been completed ,
- * A former and machined shims in place to create new flange face ,
- * Completed application ,

The application was carried out in accordance with Belzona Know-How System Leaflet VPF-3. After the surface was prepared, a former and machined shims were used to create a new spiral wound flange face. After the flange face forming was complete, the internal surfaces of the pipe elbow had been coated with Belzona 1391.
