# BELZONA REINFLATES FENDER

ID: 4806

Industry: Marine  
Application: SOS-Ships and Offshore Structures

Customer Location: Dredging company, Abu Dhabi, U.A.E.  
Application Date: October 2013

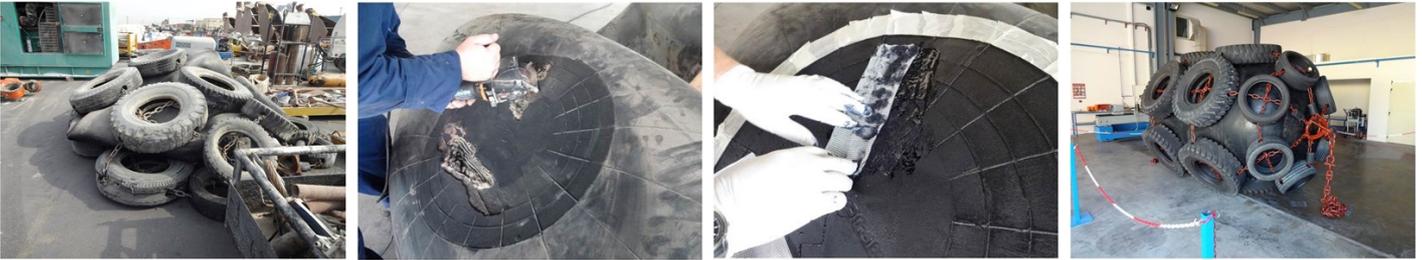
## Photograph Descriptions

Although wrapped with tyres on chains to help protection, the fenders were in need of a full service or replacement. Punctures had deflated the fenders rendering them useless.

- \* Initial inspection of deflated fender ,
- \* Stitching of punctures ,
- \* Application of Belzona 2111 incorporating ,
- \* Reinforcement tape Finished application ,

Application was carried out in accordance with Belzona Know-How System Leaflet SOS-12. Surfaces were prepared using a power wire brush. Punctures were stitched together using Nylon thread. After Conditioning the areas were rebuilt with Belzona 2111 incorporating Belzona 9341 (Reinforcement Tape).
