# BELZONA COLD PLATE BONDING SOLUTION FOR SLUDGE TANK

**Industry:** Water / Wastewater  
**Application:** TCC-Tanks and Chemical Containment Areas  
**Substrate:** Glass coated mild steel  
**Products:** \* Belzona 1161 (Super UW-Metal) ,  
\* Belzona 5831 (ST-Barrier) ,

**Customer Location:** Sewage treatment works - UK  
**Application Date:** 19/11/2013

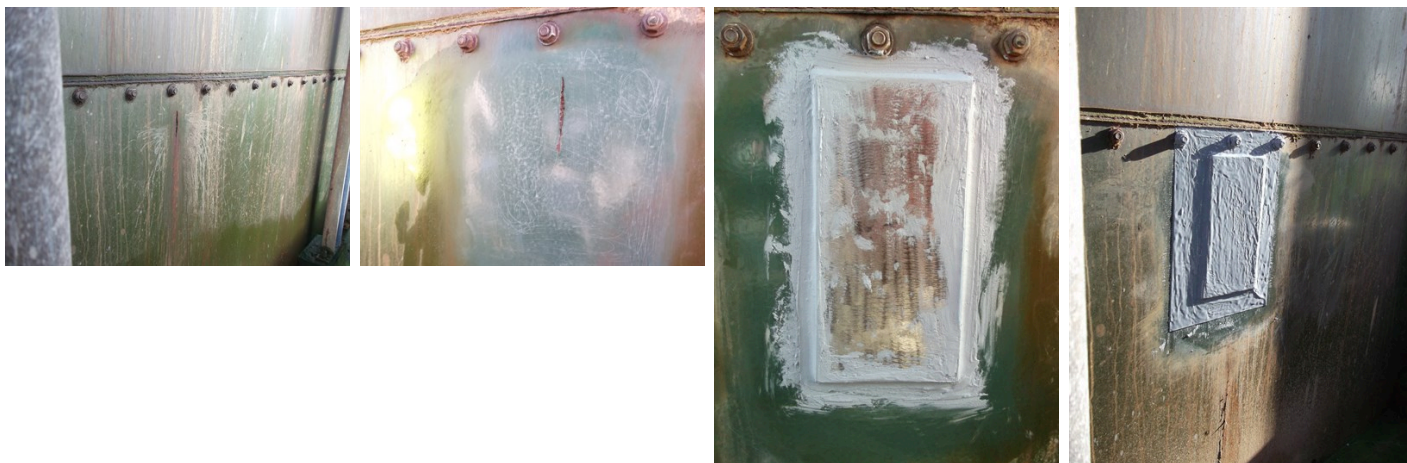
The primary sludge tank was suffering from through wall corrosion at the lowest panel level. The tank could not be taken off line due to demand and any repairs would have to be carried out without hot works or the use mechanical equipment due to the risk of sparks.

- \* Through wall corrosion to primary sludge tank ,
- \* Surface preparation carried out by hand abrasion ,
- \* Repair with plate cold bonded over the through wall corrosion using Belzona 1161 ,
- \* Completed application ,

Through wall corrosion on sludge tank fabricated from glass coated mild steel.

The application was carried out in accordance with Belzona Know-How System Leaflet TCC-3. After cleaning the area surface preparation by hand abrasion was carried out. A repair plate was cold bonded over the through wall defect using Belzona 1161

finally Belzona 5831 was applied to the entire repair area.
