# BELZONA® 4111 (MAGMA-QUARTZ) KEEPS PRODUCTION ON TRACK

Customer Location: Animal food manufacturer - Missouri USA

Application: FPA-Floor Problem Areas

Loading dock - stainless steel plate

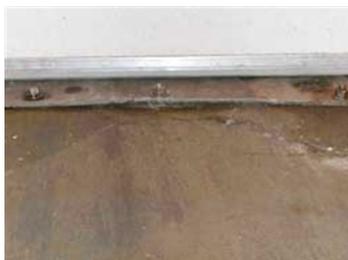
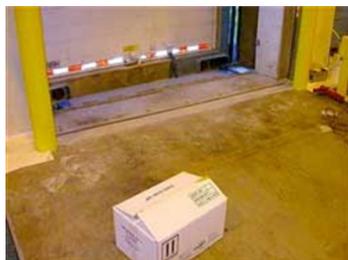
Fork lift traffic damaged stainless steel plate being bent by fork lift trucks pushing pallets into it and lifting it up. Needed a solution to avoid further damage.

- \* Close up of the problem ,
- \* Surface prepped ,
- \* Ready for traffic ,

Application was carried out in accordance with Belzona Know-How System Leaflets FPA-5 and FPA-10.
