# BELZONA® 4111 (MAGMA-QUARTZ) KEEPS PRODUCTION ON TRACK

Customer Location: Animal food manufacturer - Missouri USA

Application: FPA-Floor Problem Areas

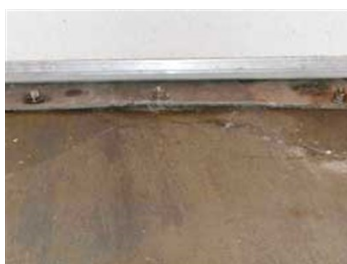
Fork lift traffic damaged stainless steel plate being bent by fork lift trucks pushing pallets into it and lifting it up. Needed a solution to avoid further damage.

- \* Close up of the problem ,
- \* Surface prepped ,
- \* Ready for traffic ,
