# BELZONA SEALS A TRANSFORMER MAIN FLANGE

ID: 4810

Supply Transformer ST6 located at electricity substation within steel manufacturing plant.

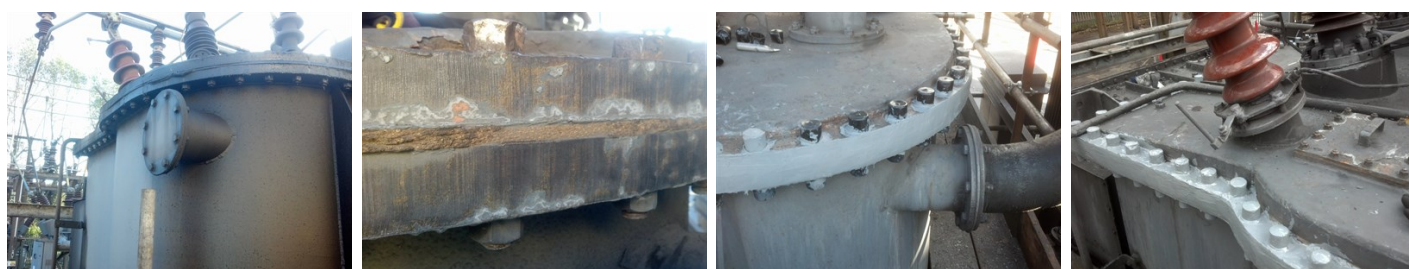
## Photograph Descriptions

The main flange was discharging high volumes of oil through the failed gasket system, together with loss through the top and bottom bolt heads. Continual tightening of the bolts was no longer proving effective on this aged transformer. The Client sought a comprehensive solution to seal the main flange and bolt heads.

\* Transformer prior to application Close up substrate preparation Main flange sealed and bolt head encapsulation Repair areas completed following Belzona 5831 coating ,

Application was carried out in accordance with Belzona System Leaflet VPF-11. Due to a strict outage period and to enhance full success, the Client dropped the oil level beneath the flange level and created the correct working habitat and heat source to reduce product cure time. Substrate was prepared by MBX Bristle Blaster. Residual leaks were sealed with Belzona 1291 & 1221. Flange joint was sealed by applying Belzona 1161 & Belzona 9341 (Reinforcement Tape). The bolt and nut heads were fully encapsulated using a disposable former containing Belzona 1161. Once cured the formers were removed and the prescribed repair areas coated with Belzona 5831.

The leak sealing application was successful following recharge of oil and when the transformer was placed back in service. The flange and bolt heads have shown no further signs of leaking. This has resulted in significant cost saving and eliminated risk to the local environment. Belzona provided a full turnkey solution to the Client.
