NON-COMPLIANT WRAP KEEPS 30" LINE IN SERVICE

ID: 4812

Industry: Oil & Gas

Application: VPF-Valves, Pipes and Fittings

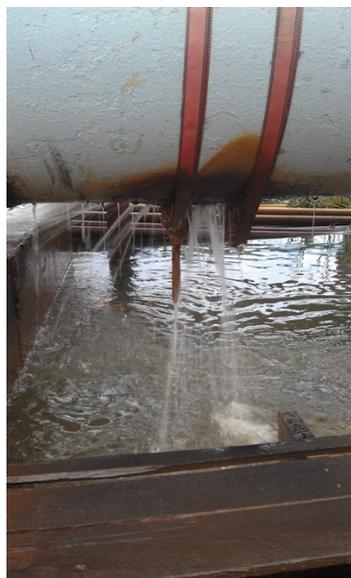
- * 30" diameter effluent line at a petroleum terminal in NJ. ,
- * Holes and thin wall revealed. ,
- * Applying a second layer of Belzona 1111 over the first wrap. ,
- * Two coats of Belzona 5811 was applied over the finished wrap repair. ,

The 30" diameter effluent line had three separate areas where corrosion and thin wall pipe allowed a large amount of water to pond near an access walk and traffic area. With winter coming, the plant wanted to fix the leaking piping and eliminate the potential safety issues of icy conditions on the access walk and traffic area. Operating pressure is <5 psi. Water would have to be

Surface was prepared by abrasive blasting to SSPC-SP10 near white. Patches were made to holed areas using Belzona 1111/Belzona 9341 in accordance to a modified version of VPF-11a, Low Pressure. Then Belzona 1111 was applied to the entire outer surface and wrap of Belzona 1971 wetted out Belzona 9371 was applied with a 50% overlap. A second layer of Belzona 1111 was applied along with a second wrap of Belzona 1971/Belzona 9371. It was completed by adding a Belzona 5811 coating.

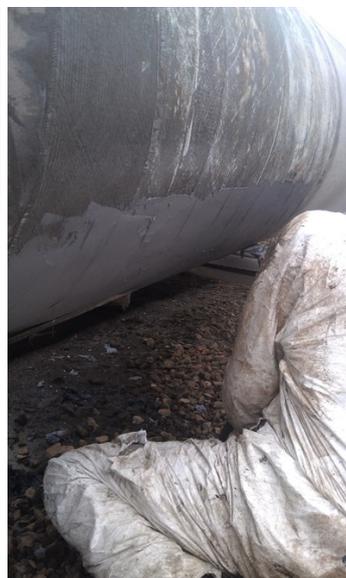
Holes and thin wall.
