# BELZONA REPAIRS/PROTECTS LP STEAM DIAPHRAGM

ID: 482

Low Pressure Steam Turbine Diaphragm

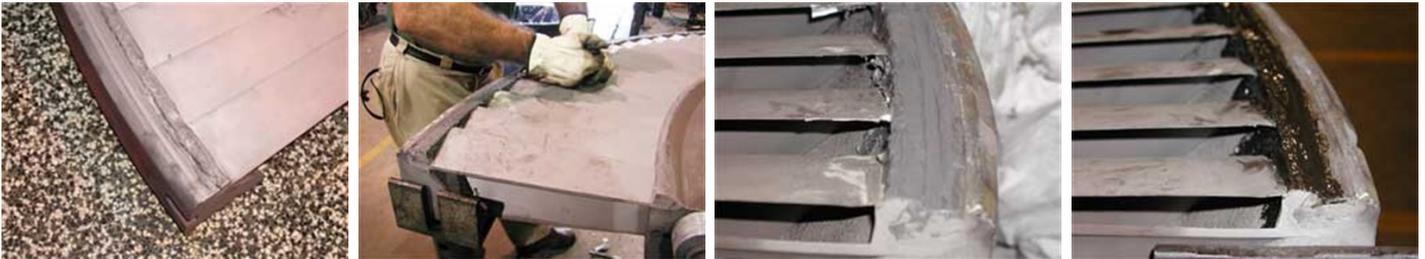
Problem  
*Erosion*

- \* 1. & 2. Erosion damage is evident ,
- \* 3. Belzona® 1111 (Super Metal) in place ,
- \* 4. Completed application ,

Application was carried out in accordance with a modified version of Belzona Know-How System Leaflets CEP-3 and CEP-5.

Sheet metal shields were produced to go over the diaphragms. Welding was considered, but time and costs associated with that were prohibitive. They were able to avoid the excessive cost of welding and its extended downtime. The Belzona approach kept the equipment out of service only one week, thereby keeping the power plant on schedule during their planned outage.
