BELZONA REPAIRS AND PROTECTS LEAKING BALCONY

ID: 4823

Customer Location: County Council, UK
Application Date: November 2010

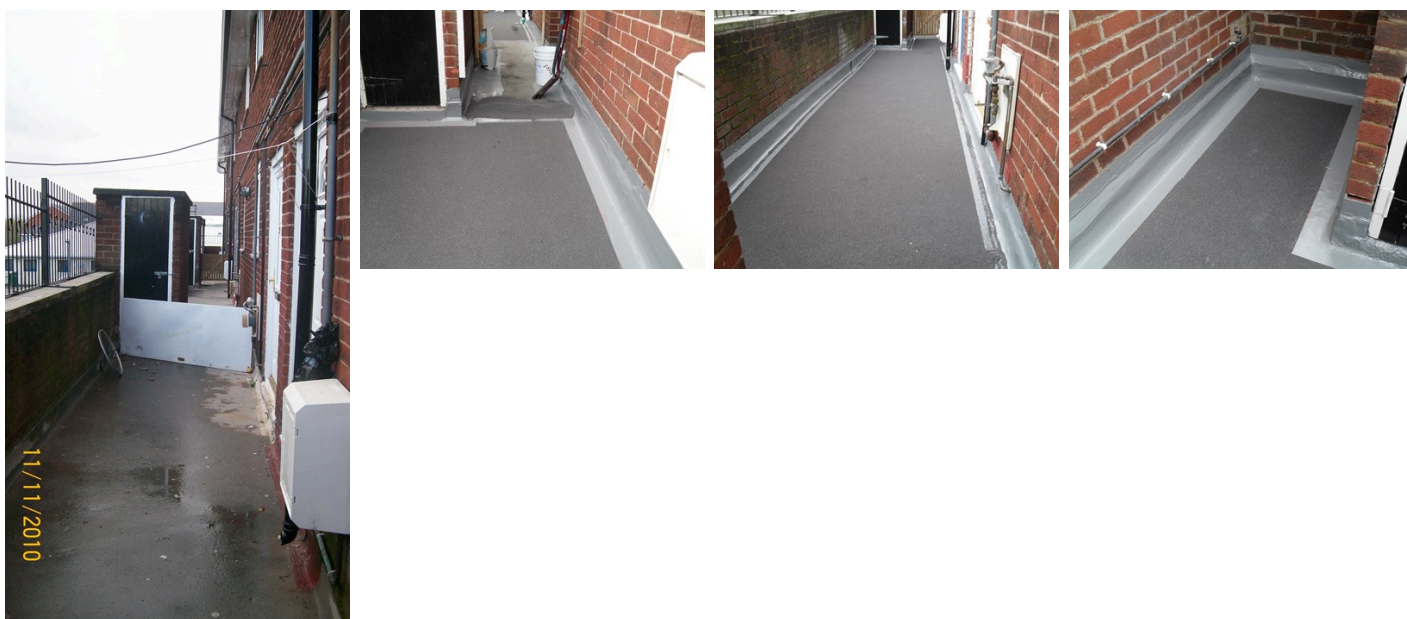
Photograph Descriptions

Over the years the cantilevered balcony had dropped allowing a gap to form between wall and the balcony itself. There was then water ingress through the gap into the shops below.

- * Balcony before work commenced ,
- * During the application ,
- * Completed application ,
- * Further view of the completed application ,

The application was carried out in accordance with Belzona Know-How System Leaflets RPA-2 & RPA-8. Belzona 4111 was used to rebuild damaged masonry and then the entire area was sealed with a fully reinforced Belzona 3111 system before applying a further coat of Belzona 3131 blended with Belzona 9231 aggregate to create a hard wearing non-slip surface.
