SUCCESSFUL RESTORATION OF ROOF IN CENTRAL LONDON WITH BELZONA

ID: 4824

Industry: Commercial Facilities
Application: RPA-Roof Problem Areas
Substrate: Single-ply membrane
Products: Belzona 3111 (Flexible Membrane)

Customer Location: Finance company, central London
Application Date: August 2012

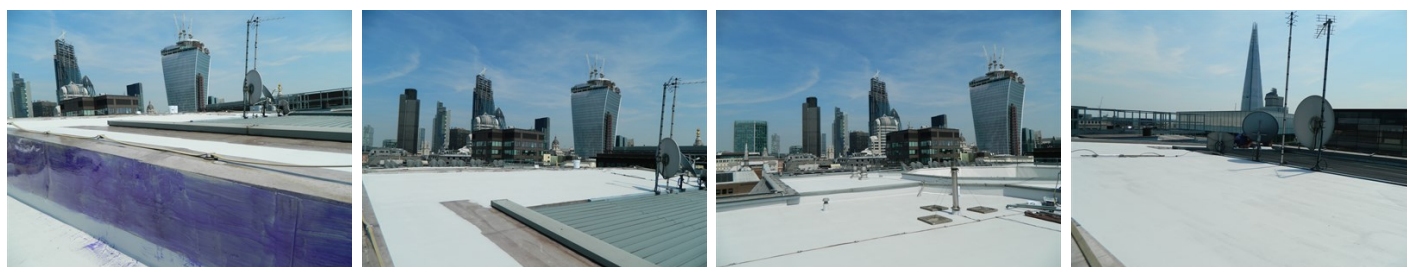
Photograph Descriptions

Surface being conditioned to ensure good adhesion
First coat of Belzona 3111 applied
Completed application
Completed application

The application was carried out in accordance with Belzona Know-How System Leaflet RPA-1. The upper level roof was cleaned and prepared before application of a fully reinforced Belzona 3111 system.
