# BELZONA SAVES ENGINE BLOCK

ID: 4825

Application: *ENC-Engines and Casings*

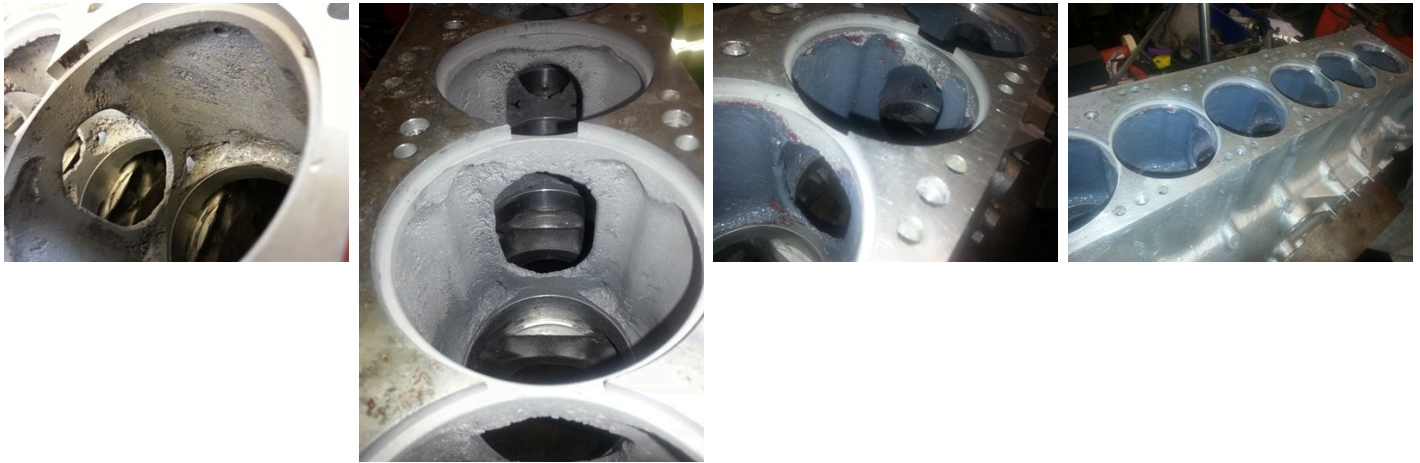
*The engine block had a hairline crack and was badly pitted around the cylinder liners. Due to the location of the crack, it was difficult to reach to weld effectively and the pitting needed to be eradicated.*

\* The damaged engine block prior to cleaning The block being repaired with Belzona 1111 Second coat of Belzona 1392 being applied The finished block ,

Application was carried in accordance with Belzona Know-How System Leaflets ENC-1 and ENC-6.

The customer chose to use the Belzona method as it offered a reliable repair, future protection against erosion and corrosion as well as improved efficiency for the engine. The previous method of welding had been taking up to 2 weeks and there was a risk of causing further damage to the block through the welding process. The Belzona application took 2 days to complete.
