# BELZONA FIXES TRIP HAZARD

**Industry:** Buildings & Structures  
**Application:** FPA-Floor Problem Areas  
**Substrate:** Stone  
**Products:** \* Belzona 4131 (Magma-Screed) ,

**Customer Location:** College, Lancing, West Sussex, UK  
**Application Date:** February 2012

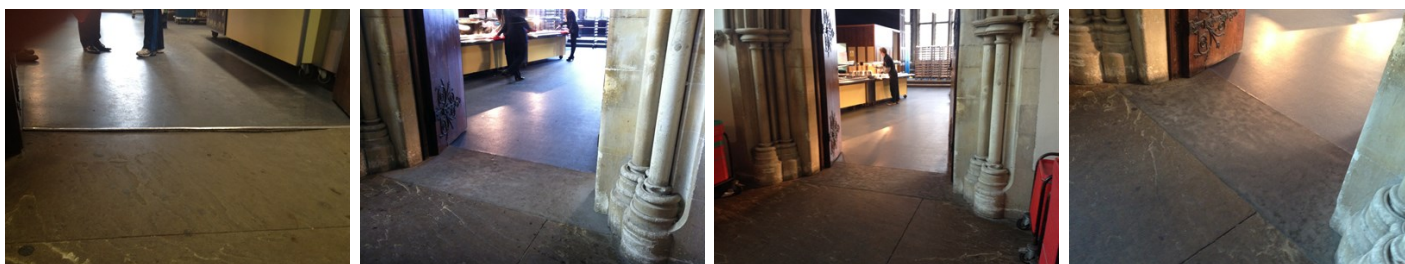
The stone had worn down over the years creating a lip of about 20mm between the stone floor and the adjoining vinyl floor, creating a trip hazard. They required a repair sympathetic to the stone and which would cause minimal disruption to the canteen operations.

\* 1. Before application 2. Completed application 3&4. Repair still in good condition following revisit 2 years on ,

Stone floor at threshold to college main canteen servery.

Application was carried out in accordance with Belzona Know-How System Leaflet FPA-1.

The client had previously used other cementitious repair systems in the past which had failed prematurely. They turned to Belzona after seeing how Belzona 4131 can be used in harsh environments and returned to service quickly. Following a recent revisit two years since the application, the repair remains in excellent condition.
