BELZONA RENUEVA UN TAMBOR MOTRIZ DEFORMADO

ID: 4848

Ubicación del cliente: Mina de carbón en Macedonia
Fecha de aplicación: Agosto 2002

Tambor motriz de una correa transportadora revestido de goma

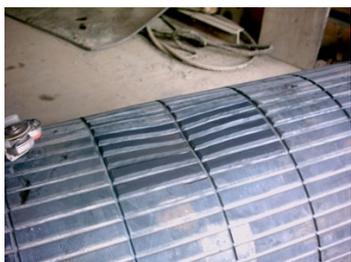
El tambor motriz tenía una cubierta de goma de 15 mm. La superficie del tambor se deformó mecánicamente durante su transporte con un montacargas.

- * Vista del tambor dañado ,
- * Preparación de la zona deformada ,
- * Aplicación concluida ,
