# REDUCED DOWNTIME, COSTS SAVED WITH BELZONA

ID: 485

Customer Location: *Alumina plant - Texas USA*  
Application Date: *November 2004*

Skimmer rail on a large clarifier - 630' circumference

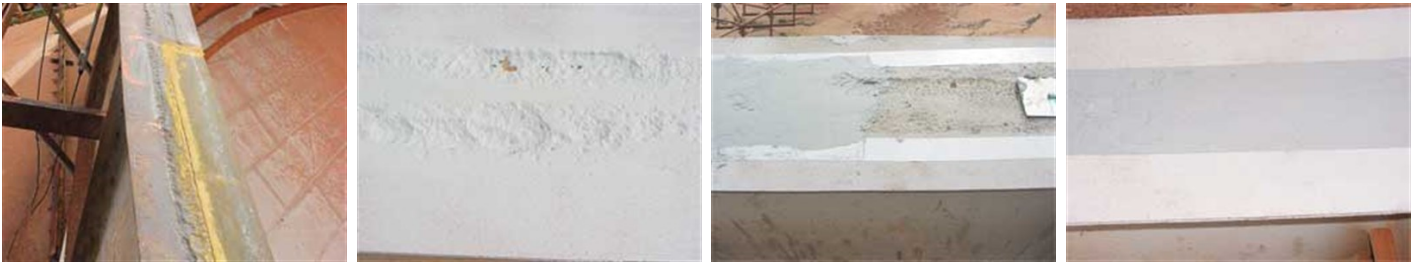
*Erosion-corrosion and wear from motion of skimmer and seaside location.*

- \* The erosion-corrosion problem is evident ,
- \* Close-up view of the damage ,
- \* A 4" band around the circumference was repaired ,
- \* Completed repair ,

Application was carried out in accordance with a modified version of Belzona Know-How System Leaflet TCC-5.

Clarifier's walls are approximately 50' tall. The choice of Belzona® 1121 (Super XL-Metal) allowed for mixing of the material on the ground, with plenty of time for staff above to apply material. Welding would have been costly and time consuming. The Belzona Solution required only three days from start to finish.
