BELZONA PROTECTS INTERNAL OF BACK-UP SEPARATOR

ID: 486

Customer Location: *Oil Refinery-Australia*
Application Date: *May 2004*

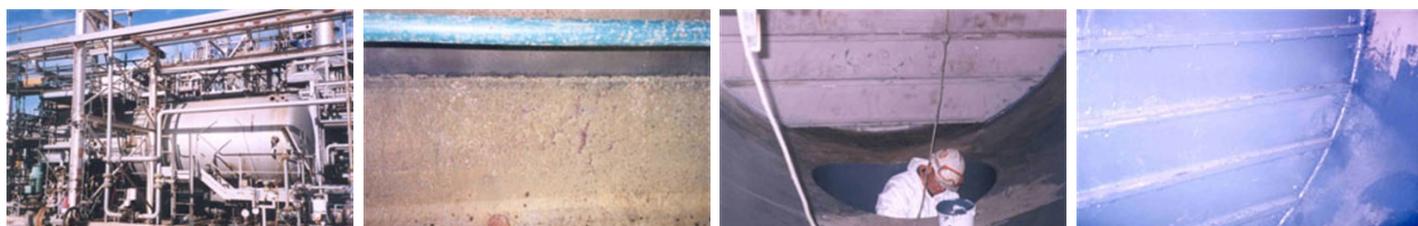
Photograph Descriptions

Internal erosion-corrosion caused by presence of sour water and operating temperature up to 100°C.

- * General view of the vessel ,
- * Failed previous coating ,
- * Application underway ,
- * One of the three baffles coated and surrounding area partially coated ,

Previous coating, a vinyl ester epoxy, had failed due to operating temperature. Belzona® 1391 selected based on previous experience in similar environments.

Application was carried out in accordance with Belzona Know-How System Leaflet TCC-5. After thorough cleaning and removal of previous coating, the vessel was grit blasted and coated with the Belzona® 1391.
