BELZONA PROTECTS CONVEYOR BELT FASTENERS

ID: 4867

Customer Location: *Gravel Pit, Panama.*
Application Date: *February 2010*

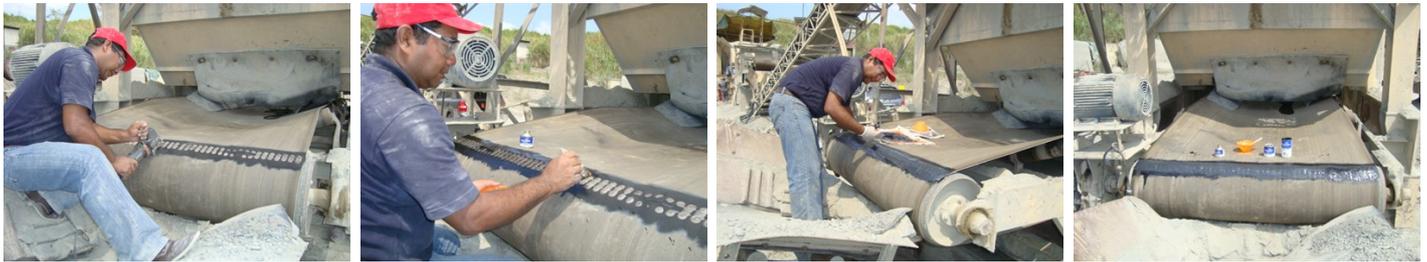
Photograph Descriptions

The belt fasteners were presenting mechanical problems due to premature failure. Client wanted fasteners sealed and protected with Belzona Elastomers

- * Surface preparation ,
- * Surface conditioning ,
- * Application of Belzona Elastomer ,
- * Fasteners protected. ,

Application was carried out in accordance with Belzona Know-How System Leaflet SHM-4. Surface was prepared using an MBX-Bristle Blaster before applying the Belzona Elastomer system.
