BELZONA BRINGS EXCAVATOR BACK TO SERVICE IN 1 DAY

Industry: *Mining & Quarrying*
Application: *MPT-Mechanical Power Transmission*

Customer Location: *Salt mine, Germany.*
Application Date: *November 2009*

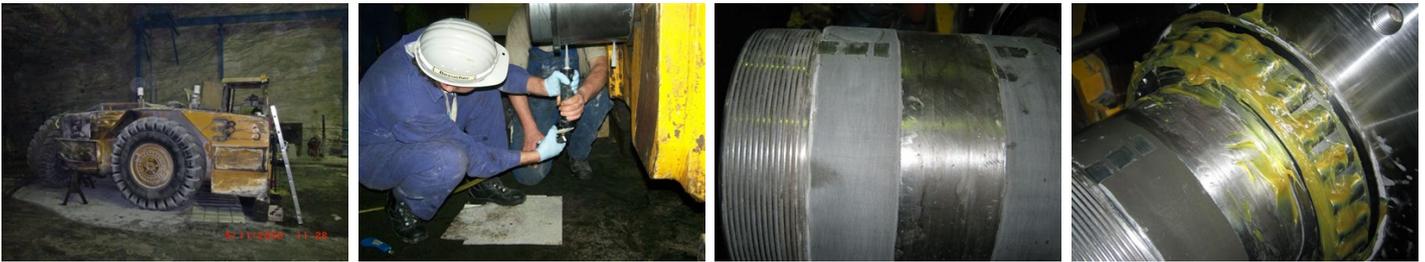
The severe conditions of corrosion and abrasion in the mine caused loss of metal in the articulated coupling, which resulted in reduced service life of the component.

- * Excavator shovel before the application ,
- * Injection of Belzona 1821 ,
- * Final application ,
- * Bearing back to service ,

Application was carried out in accordance with Belzona Know-How System Leaflet MPT-2. Belzona 1821 was injected into former to create required shaft diameter.

The complete removal of the coupling for its replacement would have taken time and money, since the support plates would have needed to be stripped down. The Belzona molding technique offered on site repair solution taking only 1 day to be completed. This significantly extended the service life of the coupling and allowed production to continue with minimal downtime.
