VULCANIZING COMPANY SAVES TIME AND MONEY

Application: *SHM-Solids Handling Machinery*

Off-road tractor's tire

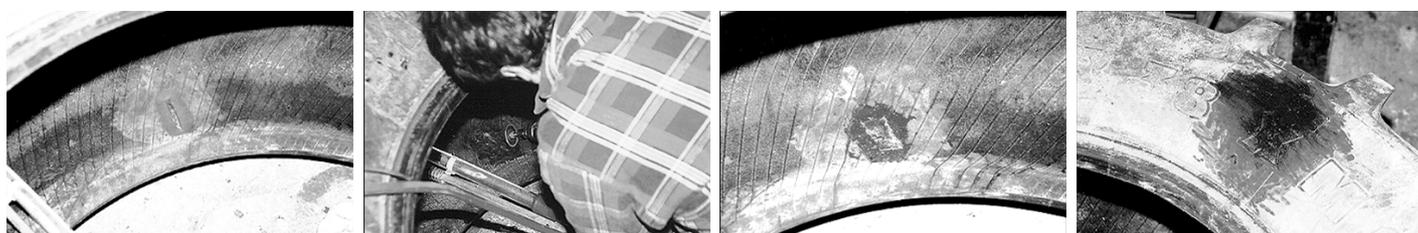
The tire had a cut which penetrated right through the wall, requiring repairs to be performed not only on the outside but on the inside of the tire as well.

- * Inside portion of the tire before the repair ,
- * Surface preparation in progress ,
- * Inside repair near completion ,
- * Finished repair to the outside ,

The affected areas (both inside and outside of the tire) were abraded then fully cleaned and degreased. Then, the substrate was conditioned using Belzona 2911 (Elastomer QD Conditioner). Belzona 2311 (SR Elastomer) was then mixed and applied incorporating Belzona 9341 (Reinforcing Tape) to the area around the damage.
