# CONDENSER TUBESHEET RESTORED WITH BELZONA

ID: 4872

Customer Location: Nuclear power station, Eastern Canada.  
Application Date: August 2013

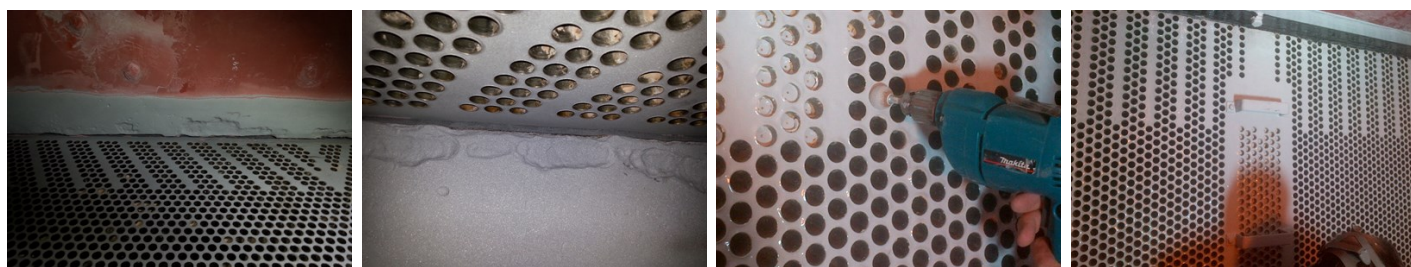
The tubesheet had suffered from bimetallic corrosion around the tubes and at the edges of the tubesheet as well as metal loss due to erosion.

- \* Tubesheet and waterbox edges following thorough grit blasting ,
- \* Close up picture of the severe pitting along the water box edge ,
- \* Following application, the Belzona 1331 was dressed down around each tube ,
- \* Finished application. Also visible at the top of the image is the Belzona 2211 joint ,

Application was carried out in accordance with Belzona System Leaflets HEX-1 & HEX-5. After grit blasting, the eroded areas were rebuilt using Belzona 1311. Once the substrate profile was restored, Belzona 1331 was applied as a two coat system to provide overall corrosion protection across the affected areas on the tubesheet and water box. Finally, a flexible joint was created between the waterbox and the tubesheet using the Belzona 2211 to allow for movement between these parts.
