MARINE EXHAUST SYSTEM INTERNALLY PROTECTED WITH BELZONA

ID: 4876

Customer Location: Luxury yacht builder, Holland
Application Date: December 2013

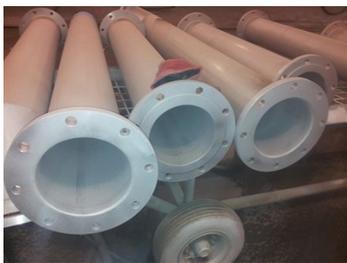
- * Exhaust sections following internal grit blasting ,
- * Internal pipe lining in progress using Belzona 1381 ,
- * Completed application ,
- * Close up of finished pipe end showing Belzona 1391T ,

Application was carried out in accordance with Belzona System Leaflet VPF-2. Belzona 1381 was applied using a single airless spray pump and internal pipe lining equipment. The ends and flange faces were hand finished using Belzona 1391T.
