BELZONA REPAIRS A DRAGSHAFT

ID: 4883

Industry: *Mining & Quarrying*
Application: *MPT-Mechanical Power Transmission*

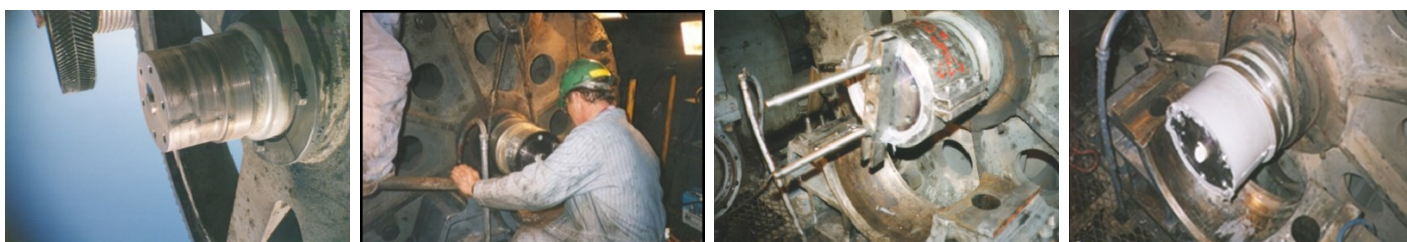
Photograph Descriptions

Worn shaft due to bearing failure

- * Initial damage ,
- * Surface Preparation ,
- * Molding Belzona 1111 ,
- * Complete application ,

Dragshaft repair with an interference fit of 0.005-0.008"

Application was carried out in accordance with Belzona Know-How System Leaflet MPT-10. A mold was made at a local machine shop, clamping on the seal surface and utilizing the window between the bearings as the second locator point.
