BELZONA REPAIRS SWING SHAFT BUSHING

ID: 4886

Customer Location: *Mining Industry, USA*
Application Date: *October 2009*

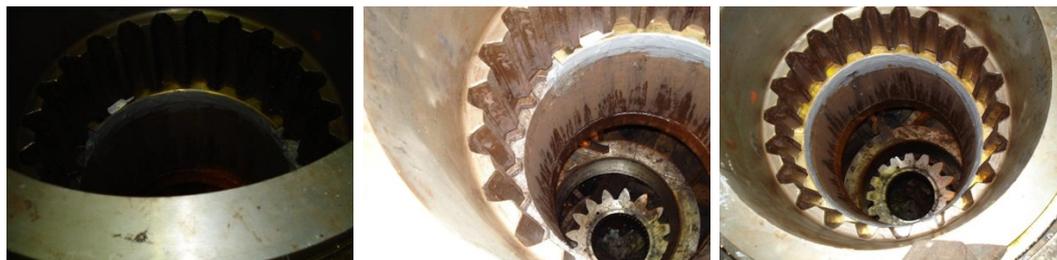
Photograph Descriptions

Swing shaft bushing are segmented brass and fit loosely. Belzona was used to shim the OEM bushings for a tighter fit.

- * Damaged bushing ,
- * Application in progress ,
- * Complete application ,

Damaged swing shaft bushing on a dragline

Application was carried out in accordance with Belzona Know-How System Leaflet GSS-7. Surface was cleaned and degreased from oils and prepared using hand tools.

Bushings were replaced often due to the loose fit. Belzona 1111 repair augmented the OEM fit thus improving run life.
